Appendix E-1
Supervisor's Daily
Logbook

Supervisor's Daily Logbook

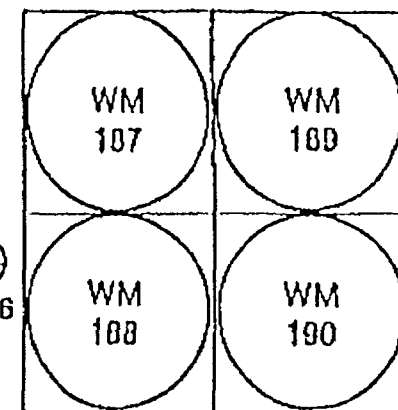
TANK FARM OBSERVATION WELLS LOCATION MAP

Wet Well
Dry Well

Highest Reading/Depth
From 1990+91 Data
Readings mR/hr.

The other excavation areas for the HLWTFR Project can be reasonably assumed to be clean. The area north of the WM-103 to 106 tanks does not have a source and the monitoring well (A-48) located there has zero readings. The west side of the tank farm area also does not have a source and the wells (A-50 & 81-2) have zero readings. The area north of WM-186 does not have a source and wells (B-7, A-44, 81-17, & 81-24) have zero readings.
